# **ADVANCED LEAK DETECTION FOR CRITICAL WATER INFRASTRUCTURE IN UK**

Langford, United Kingdom

**Client: Essex & Suffolk Water**  
**Partner: SUEZ**

# EXECUTIVE SUMMARY

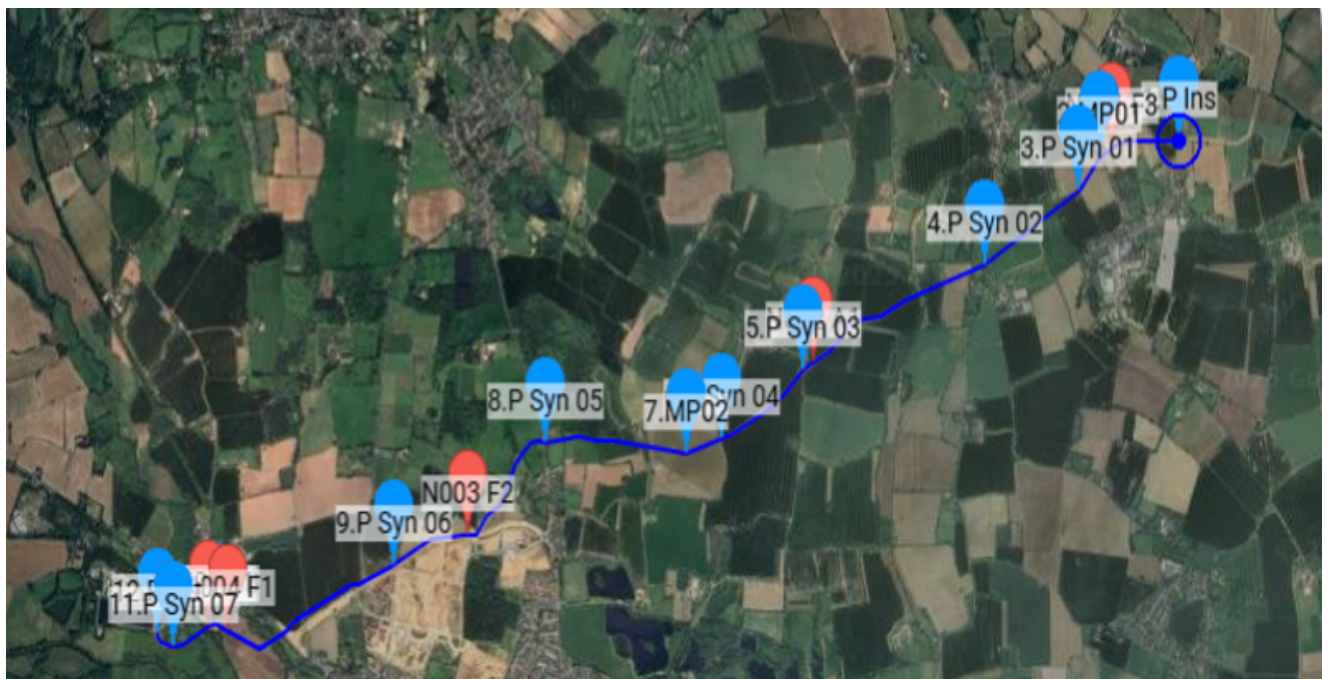
Overview of the pipeline showing the incidents detected during the inspection, synchronizer locations (P SYN), insertion point (P INS), and extraction point (P EXT).

The post-inspection analysis identified five anomalies:

- 2 major leaks (F1)
- 1 leak (F2)
- 1 leaks (F3)
- 1 anomaly (A1)

After retrieving the Nautilus sphere, a final report was delivered to Essex and Suffolk Water a week later, revealing 5 incidents. Of these 5 incidents, 2 were classified as high-severity leaks, 1 as a medium-severity leak, 1 as a low-severity leak, and 1 as an anomaly consistent with an incipient leak, which is currently almost negligible. The two main F1 leaks were estimated at a total of 1MLD.

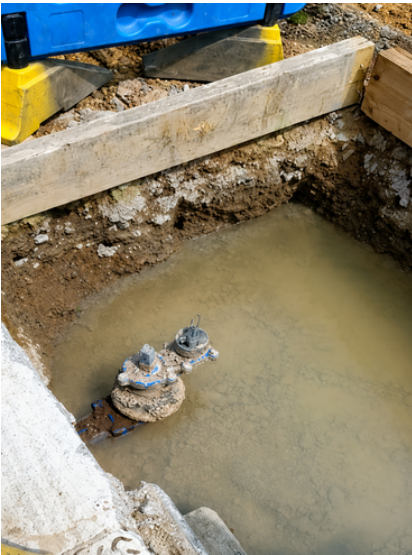
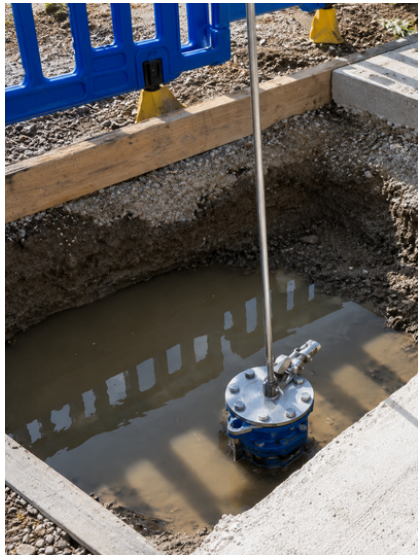
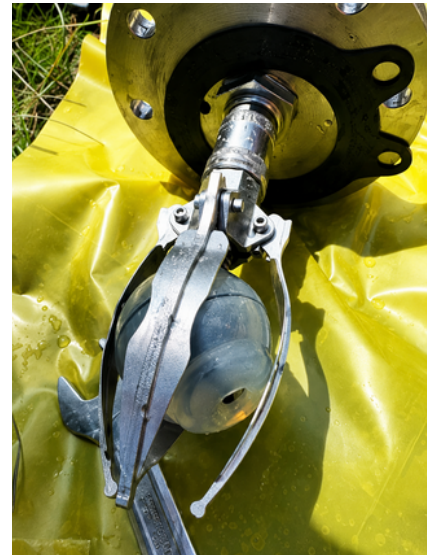
*Insertion of the Nautilus sphere using non-invasive systems*

1. Insertion: Deployed through a DN80 hydrant using push-plate method. V1 Sphere used due to minimum size requirements for insertion point. All equipment was previously disinfected. Insertion time: 30 minutes.

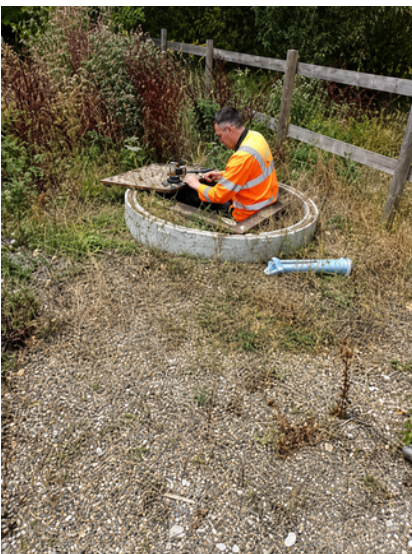
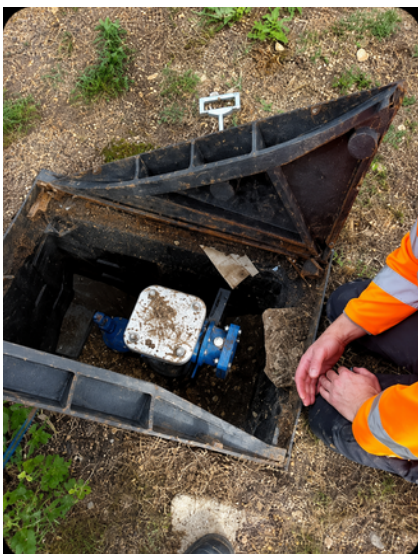
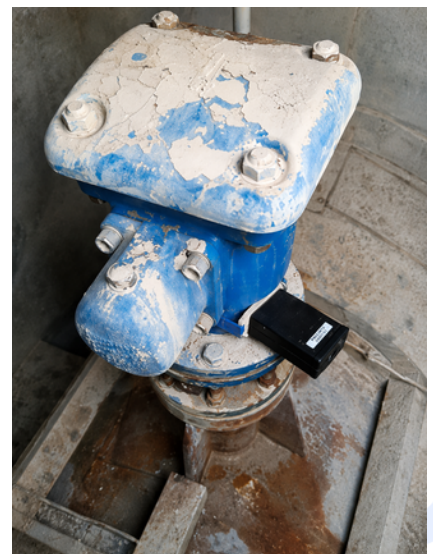
*Installation of synchronizers along the pipeline.*

2. Synchronizer Installation: 7 synchronizers were installed along the 8 km pipeline to enhance accuracy, considering possible changes in velocity. Each synchronizer took approximately 10 minutes to install. Additionally, 3 checkpoints were set up to track the sphere's progress along the route.

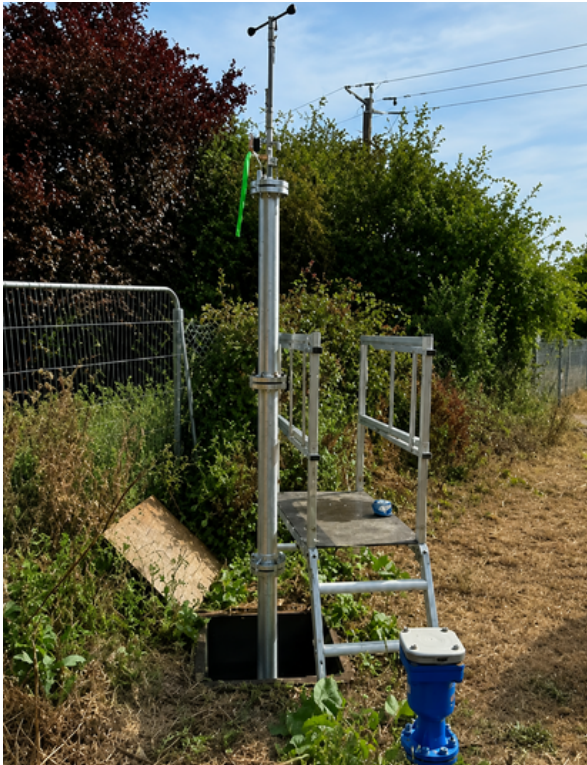
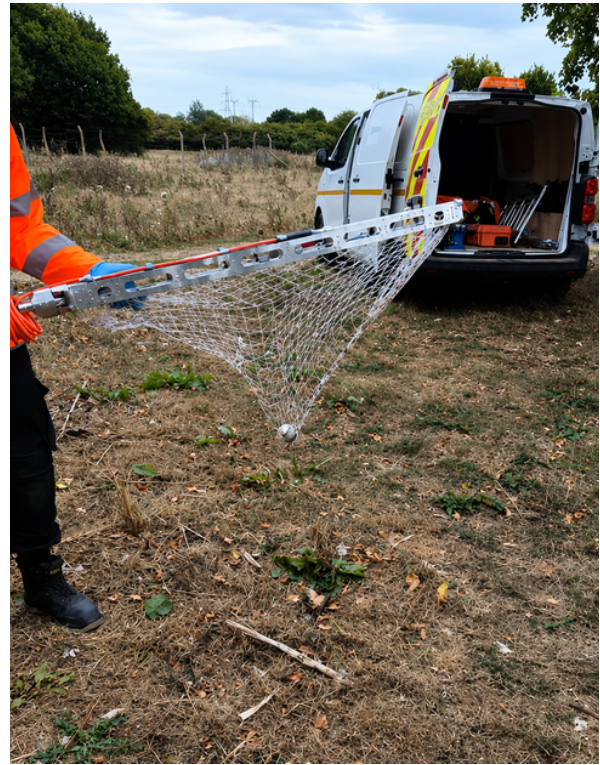
*Extraction of the Nautilus sphere*

4. Extraction: SUEZ Leakage & Condition Assessment Team mounted the Nautilus standard extraction system on top of the valve. Air valve on DN150 Tee removed and our equipment built and connected in 45 minutes. Sphere arrived at extraction point exactly at estimated time. Without cutting the service, sphere extraction took place at 18:36.
